Monitoring Streamflow, Water Levels, and Water Quality in the Wapato Lake National Wildlife Refuge, Oregon

Introduction

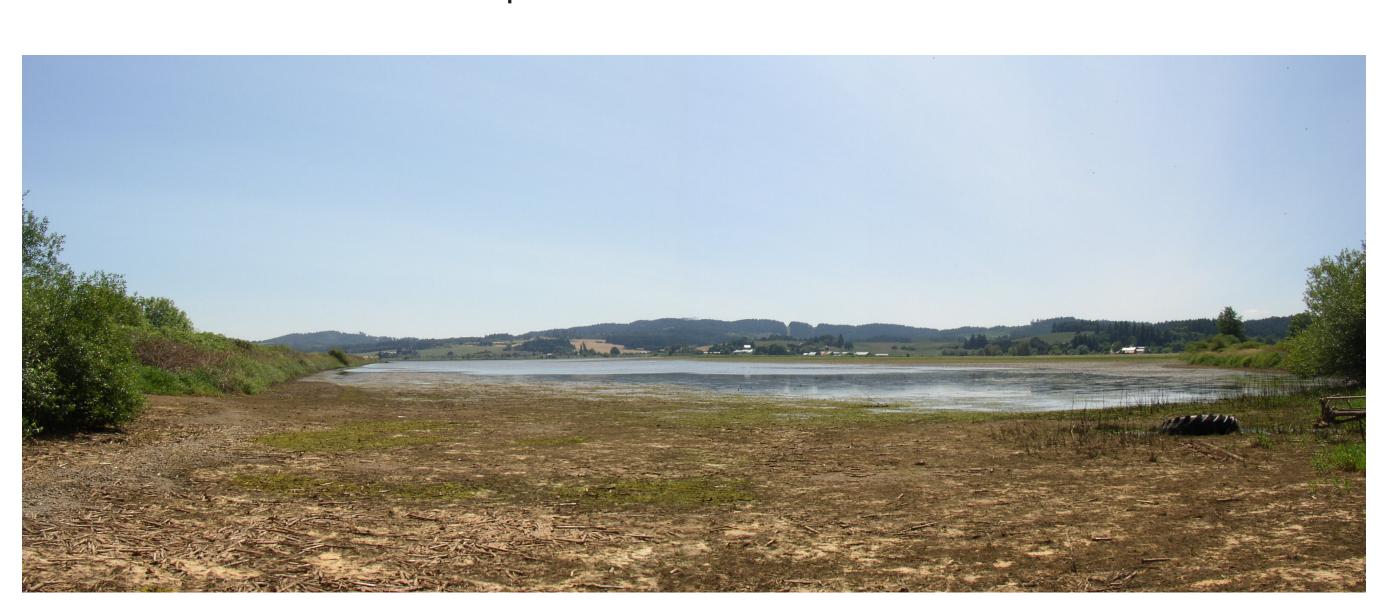
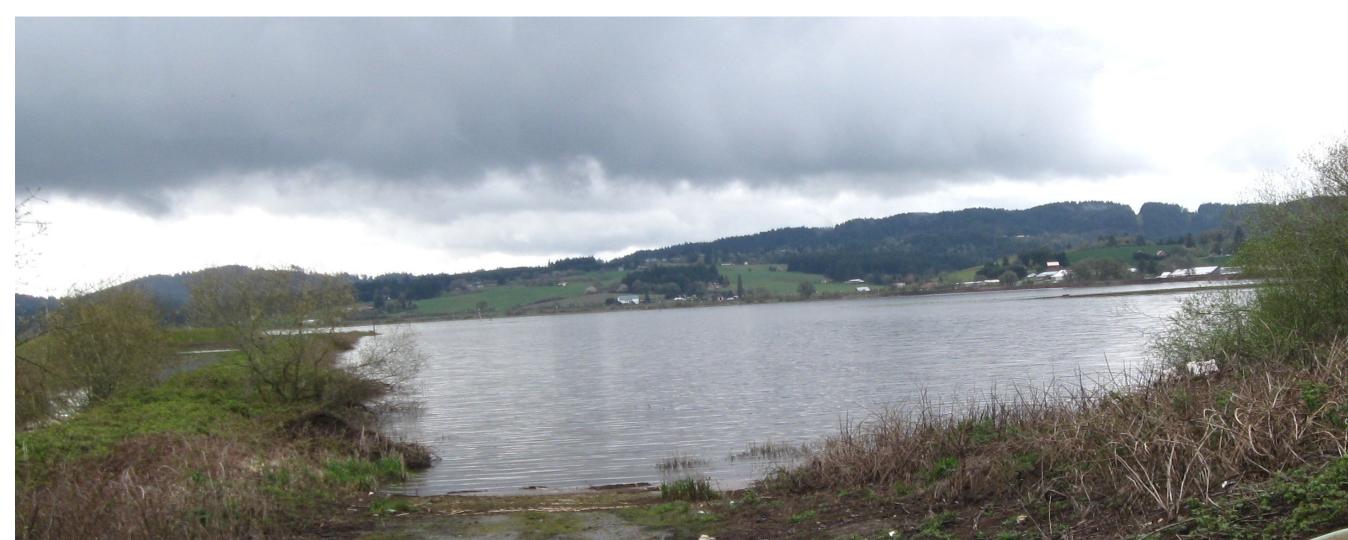
View of Wapato Lake from the pumphouse taken July 19, 2008 (top) and April 13, 2010 (bottom). Photographs by Stewart Rounds and Micelis Doyle, USGS.

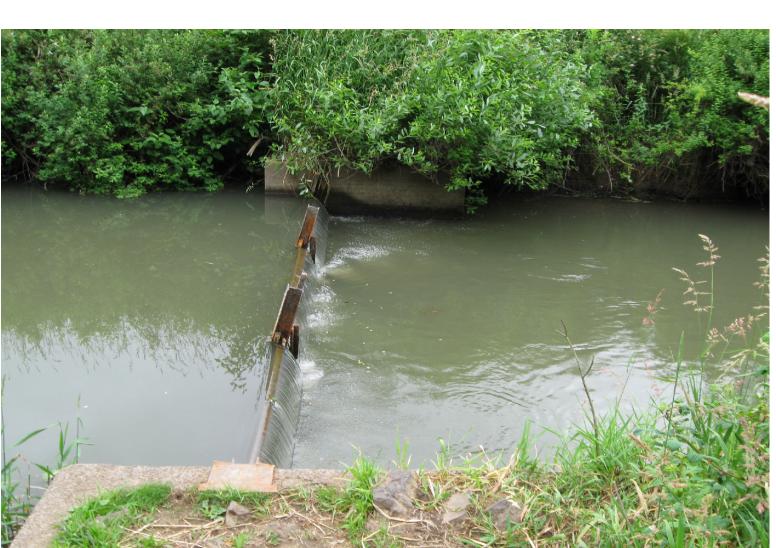
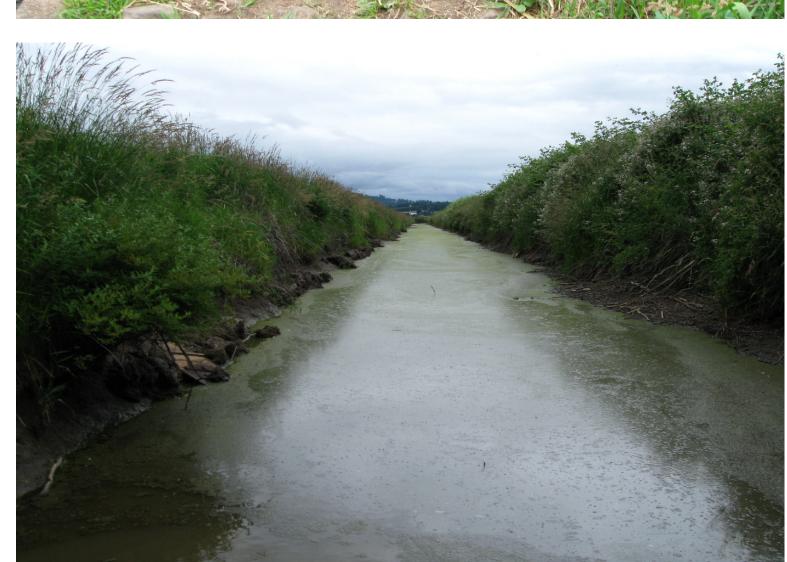
View of control on Wapato Creek outflow canal (top) and the inner canal near the pumphouse (bottom). Photographs by Norman Buccola, USGS, June 29, 2011.

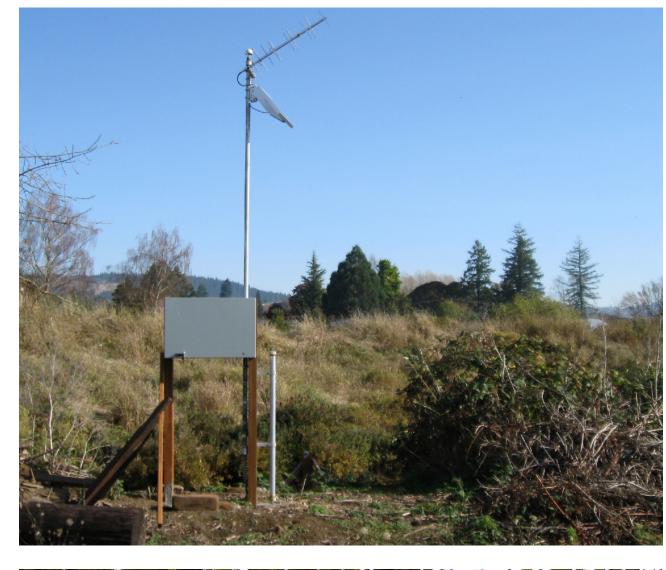
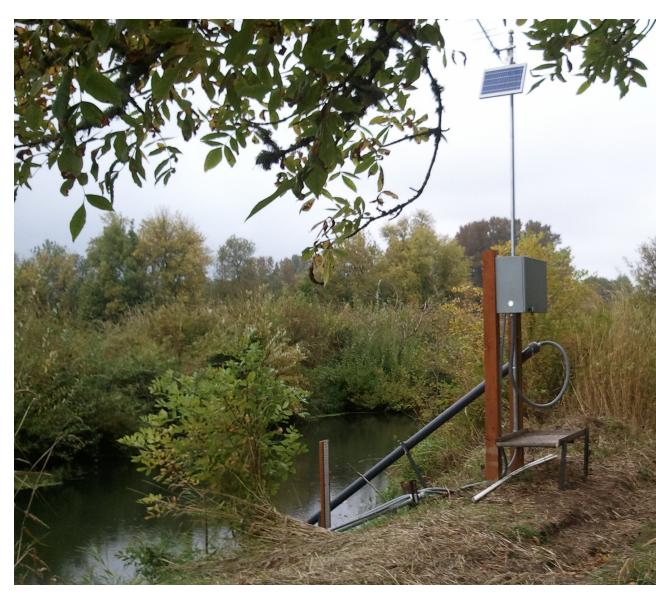
Photos of Wapato Lake water-level monitor (top) and Wapato Creek water-quality monitor (bottom) by Micelis Doyle, USGS, September 30, 2011.

Streamflow was measured at the Ayers Creek site by measuring the water level with a pressure sensor, then converting that measurement to streamflow through a stage-discharge relation determined from flow measurements collected over a wide range of conditions. Streamflow at the Wapato Creek outflow site was measured with an acoustic velocity meter that used sound waves to measure the velocity of water; the velocity data combined with water-level data were used to calculate streamflow. The water-level sensors at various sites used underwater pressure sensors to measure the water depth.

Water quality at the Wapato Creek outflow site was measured with an instrument equiped with seven different probes. The probes were maintained and calibrated every 3-4 weeks, year-round, to keep them operating properly.
