Reference : Wallick, J.R., Jones, K.L. O'Connor, J.E., Keith, M.K., Hulse, David, and Gregory, S.V., 2013, Geomorphic and vegetation processes of the Willamette River floodplain, Oregon—Current understanding and unanswered questions: U.S. Geological Survey Open-File Report 2013-1246., 70 p., <http://dx.doi.org/10.3133/ofr20131246>.

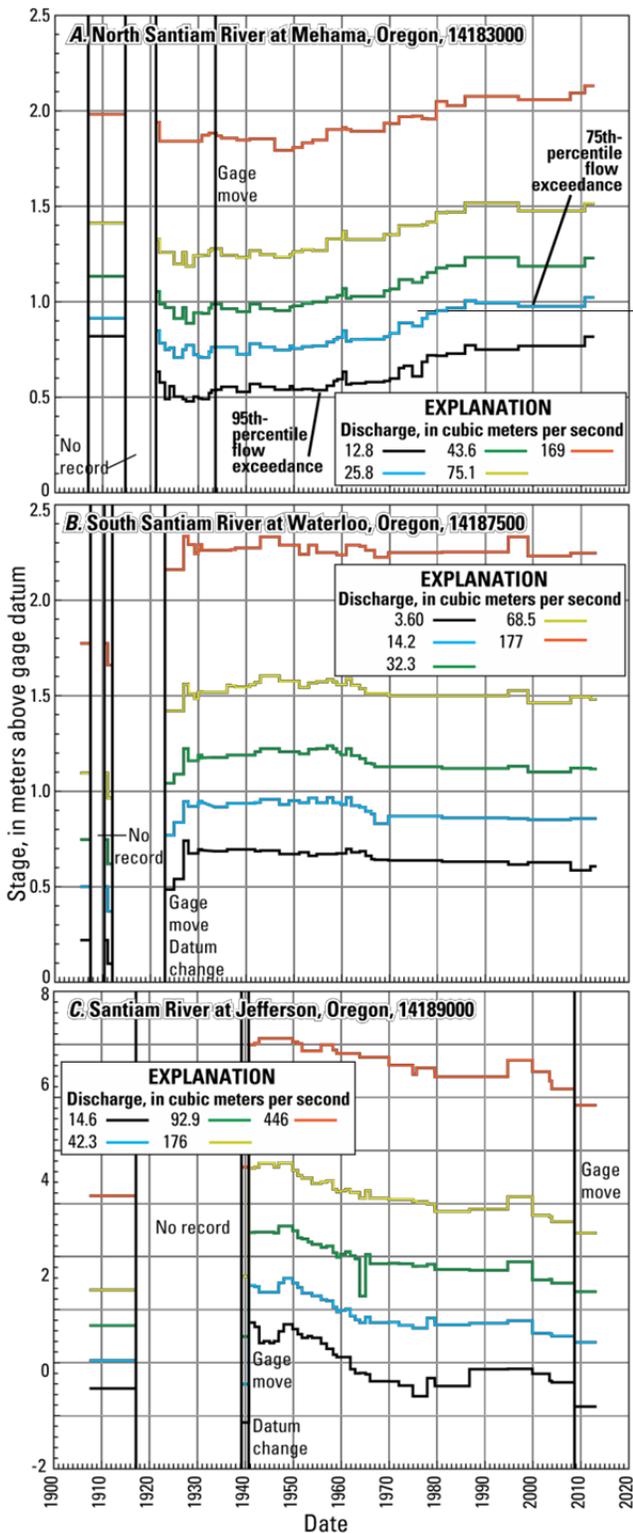
Figure 22. Specific gage analyses for the North, South, and main stem Santiam Rivers, Oregon.
